"We avoided a total blockage of the hangar door."

Power and energy quality analyser, Qualistar Class A, CA 8345

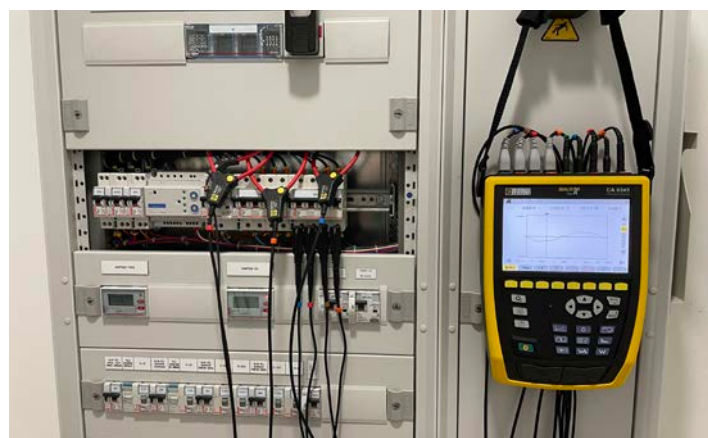
The measurements were taken using a power and energy quality analyser, the Qualistar CA 8345. We operated the door repeatedly. When friction occurred at the door's sliding rails, the measurements showed a significant increase in the current value.
